XYZ PAPER COMPANY

*No. 21 Paper Machine
Former, TAD, Dryer Cans & Reel
January 05, 2008*

Prepared by Michael Peeples
PO Number: 4500481251
Job Number: 2840

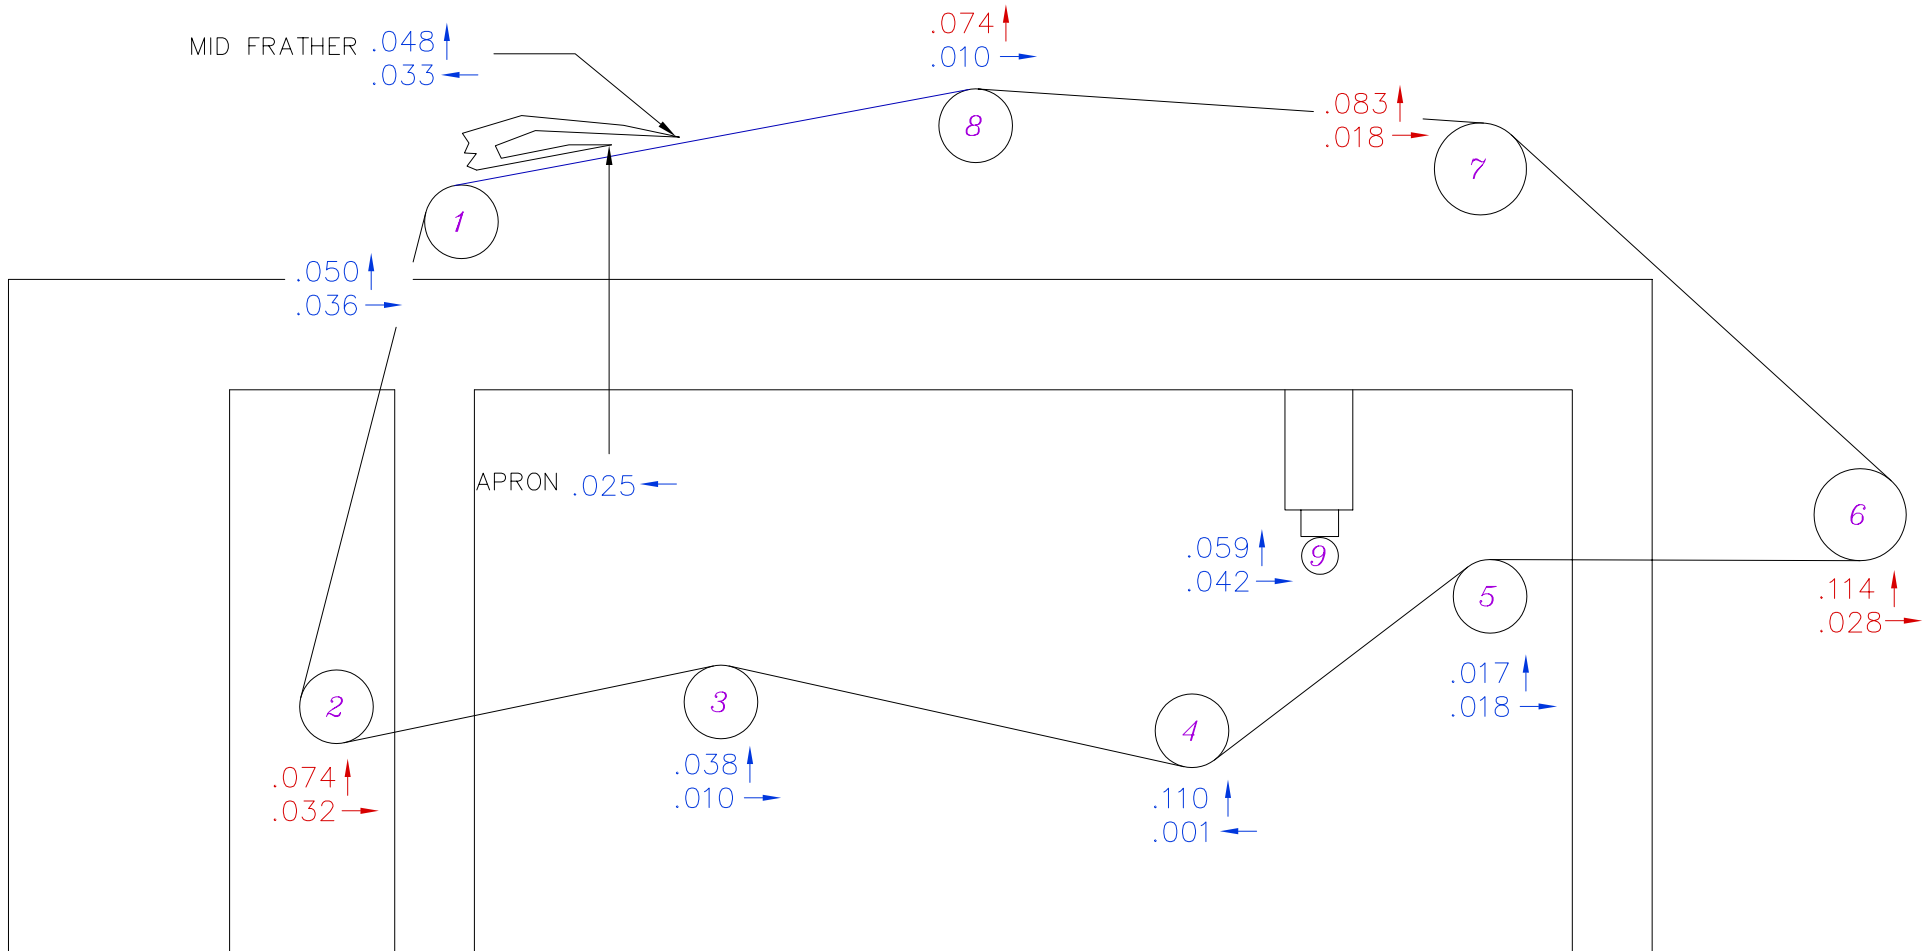
DELTA FORMER WET END ROLLS

As seen in Sketch 284-1, the inspection revealed that the level conditions are worsening over time. The last inspection showed the rolls in the Former to average 0.050"↑ on the operator's side. Currently, the rolls have an alignment condition of 0.090"↑. All of the rolls in the Former section could not be aligned during this shutdown, so no adjustments were made.

Clearly, the building is settling on the drive side of the Forming section. This is typical with paper machines and must be dealt with before severe profiling problems arise. There are several options which are done frequently:

- Adjust the level condition by re-cantilevering the forming section.
- Adjust the level condition by adding shims under the drive side support structure.

The Forming section should be placed in a level to Earth condition, or 0.010" high on the drive side, to counter the vertical misalignment.

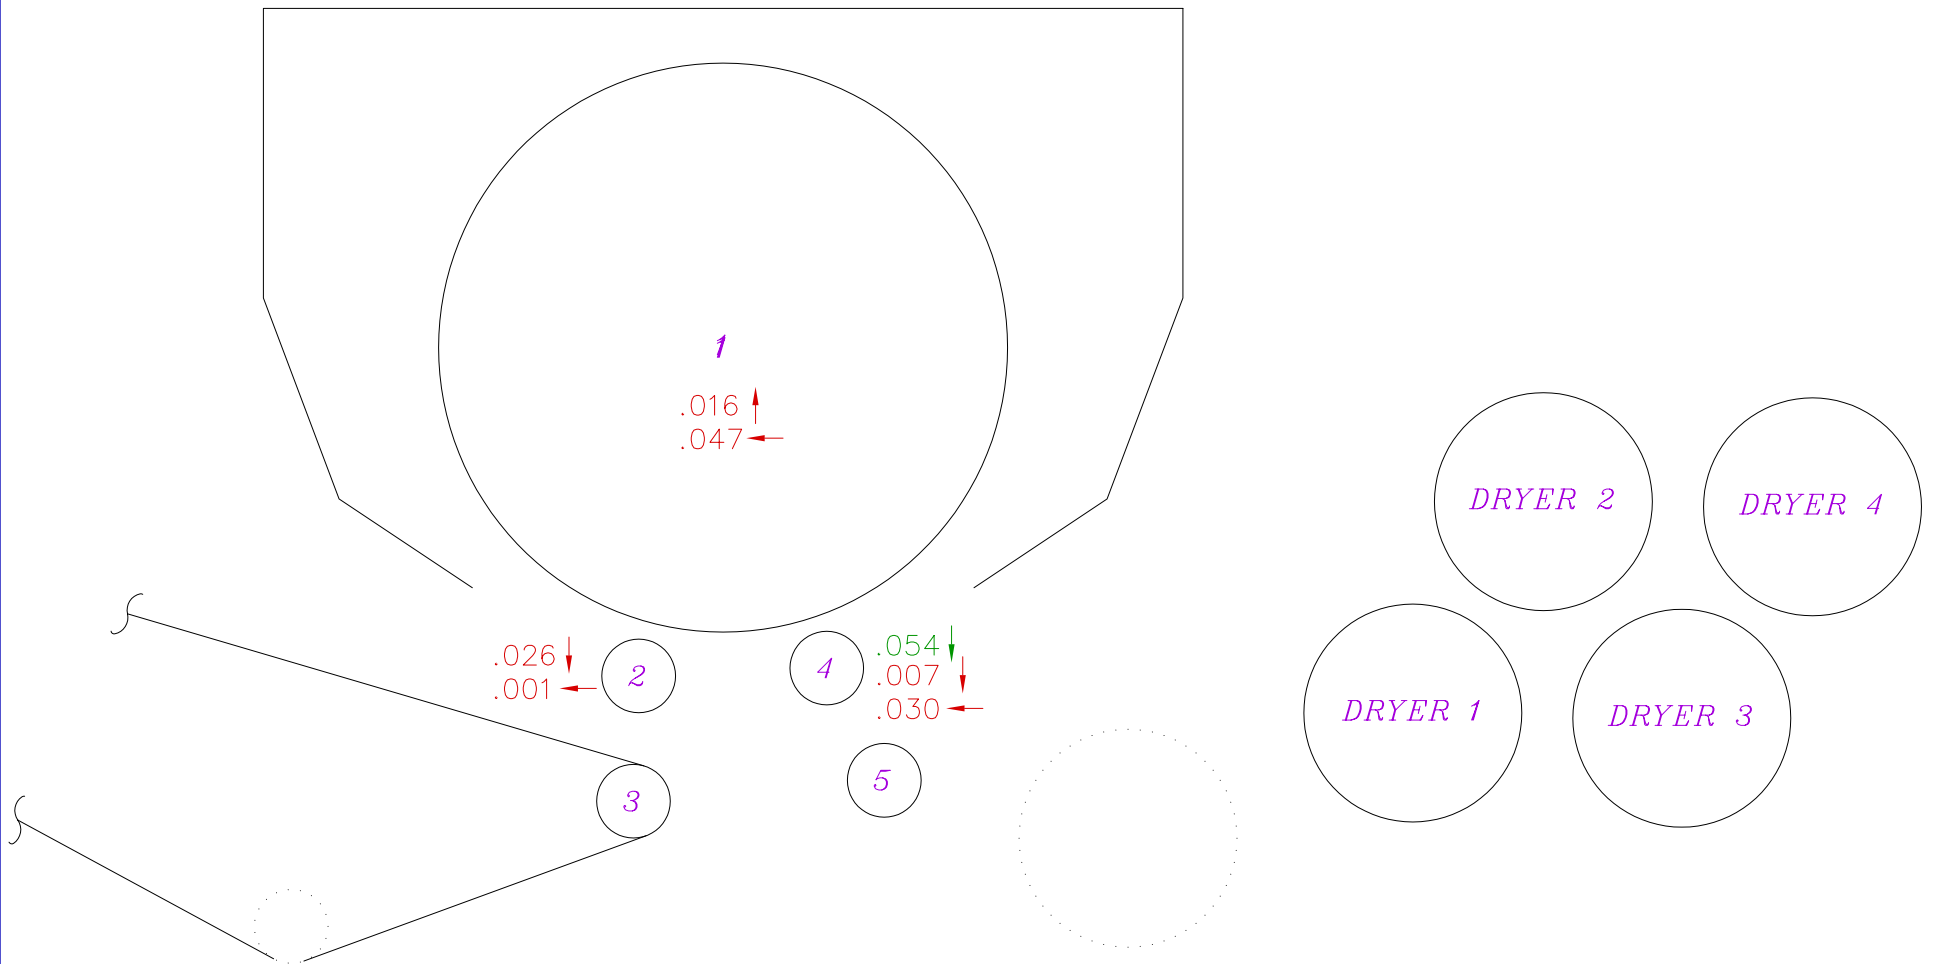
THROUGH AIR DRYER ROLLS

Background	GLASS was asked to inspect the TAD, as well as its lead in and lead out rolls.
Inspection References	The Inspection References were: <ul style="list-style-type: none">➤ <i>Vertical Attribute (Level)</i> - Level to earth➤ <i>Horizontal Attribute (Square)</i> – Perpendicular to the Stainless Steel Target Bushing baseline. The targets used were located adjacent to the Former, TAD and Dryer 12.
Inspection Results	The rolls in this section were found in similar alignment conditions as previously, with the exception of the lead-out roll. The lead-out roll was adjusted from 0.054"↓ to 0.007"↓, at the operator's side bearing. The TAD was not adjusted, as GLASS was informed that when the fabric is installed, there is no way to hold the TAD in an aligned condition.
Recommendations	Align all of the rolls in this section to a tolerance of +/- 0.010" and then pin the bearing housings to maintain alignment conditions.

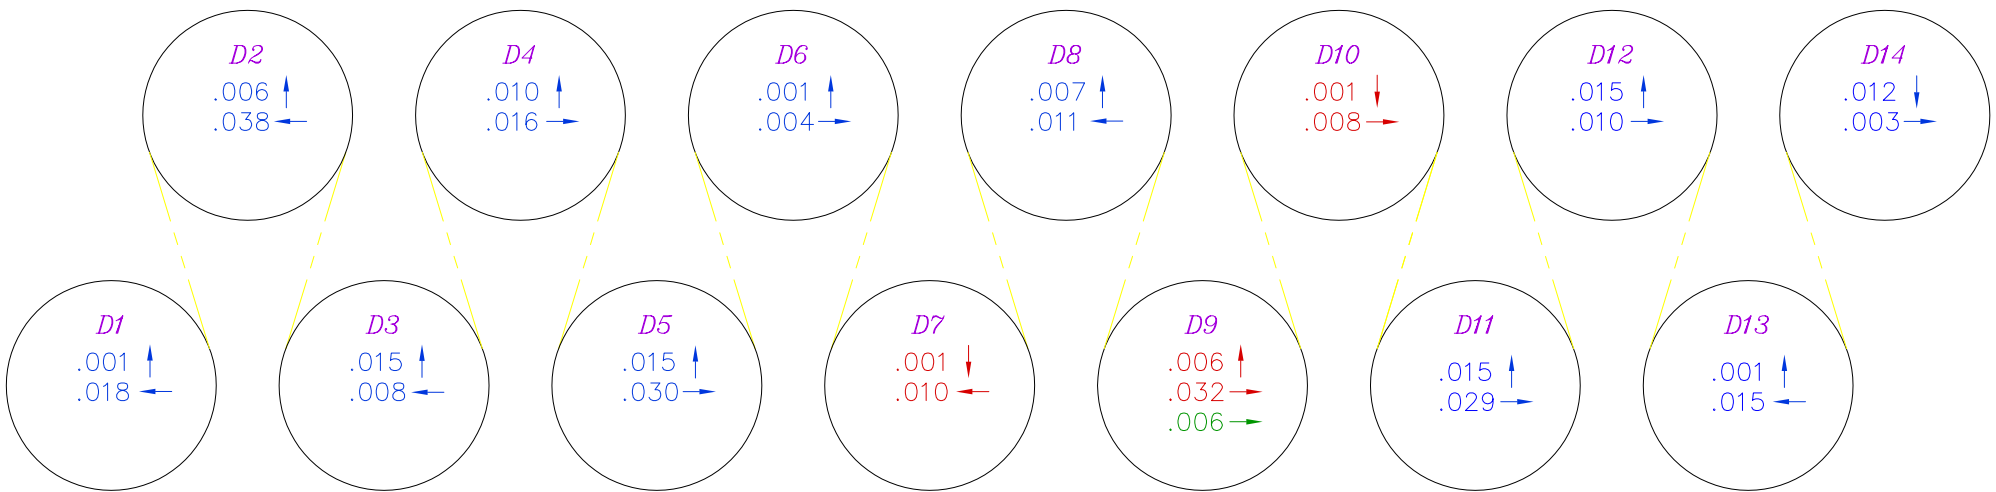
TITLE	FIRST DRYER SECTION	
MACHINE	NO. 1 PAPER MACHINE	
DRAWN FOR	XYZ PAPER COMPANY ANYTOWN, USA	
DATE	01/05/2009	GLASS GREAT LAKES ALIGNMENT SURVEY SERVICES
SKETCH	2840-4

Dryer 9 was the only can which needed alignment. Initial inspection showed it at 0.032"→. The operator's side bearing housing was adjusted until Dryer 9 was at 0.006"→.

GLASS has no record of the felt rolls being aligned. Inspect all of the felt rolls and align all of the rolls in this section to a tolerance of +/- 0.010". Misalignment of the felt rolls causes excessive felt wear and stresses the bearings unequally.

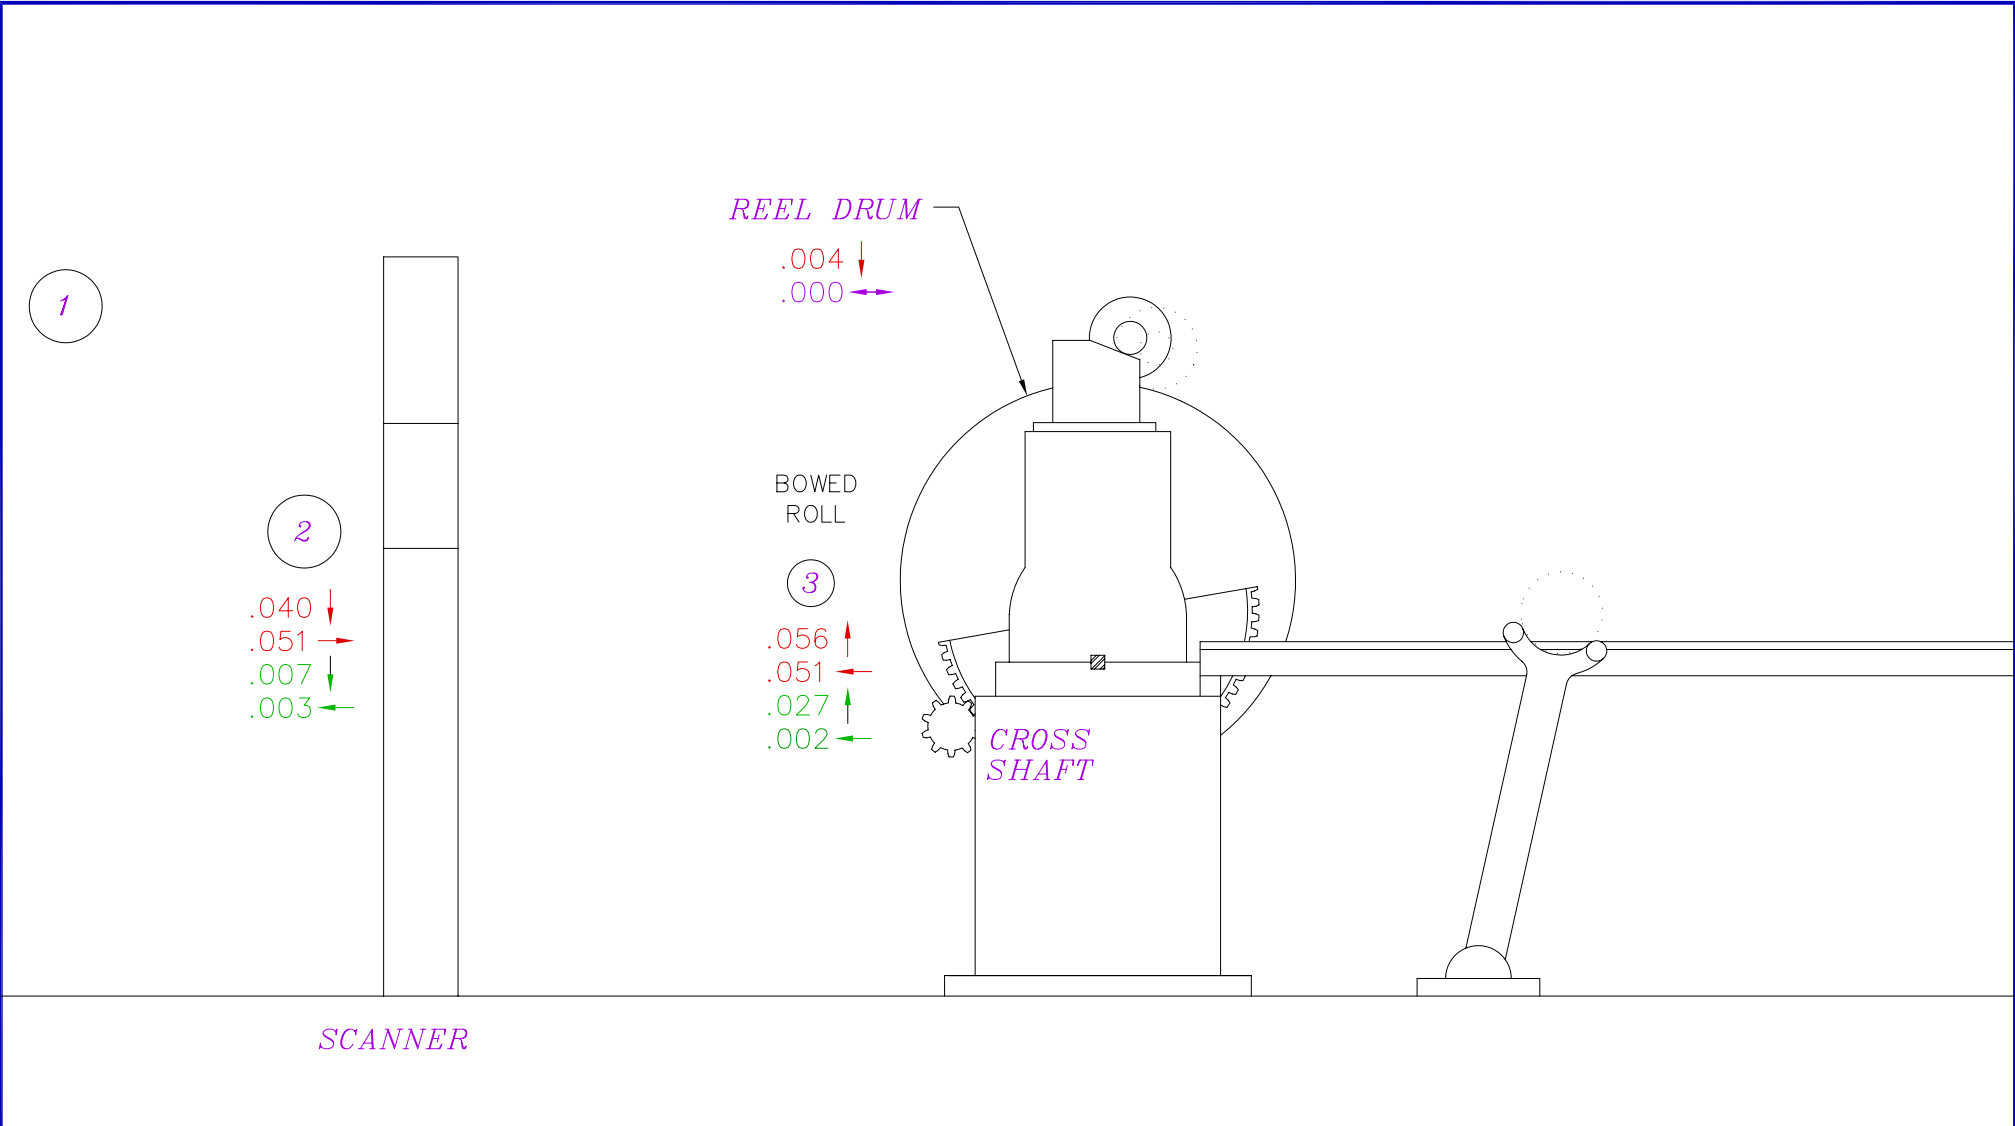
TITLE	REEL	
MACHINE	NO. 1 PAPER MACHINE	
DRAWN FOR	XYZ PAPER COMPANY ANYTOWN, USA	
DATE	01/05/2009	
SKETCH	2840-5

Background	As part of the overall alignment inspection, GLASS was asked to inspect the Reel.
Inspection References	The Inspection References were: <ul style="list-style-type: none">➤ <i>Vertical Attribute (Level)</i> - Level to earth➤ <i>Horizontal Attribute (Square)</i> – Parallel to the Reel Drum.
Inspection Results	The Reel Drum was inspected and was found to be aligned, at 0.004” ↓. Rolls 2 and 3 were both inspected and found to have misalignment by as much as 0.056” . Both rolls were shimmed and slid individually, until aligned conditions were achieved.
Recommendations	The Reel operates best when the Primary arms are timed such that the spool is aligned to the drum. Previous inspections showed adjustments were necessary from outage to outage. The last few times an alignment effort was made on the Reel, the procedure to operate the Primary arms could not be executed. GLASS recommends that the Primary arms be the concentration of the alignment effort during the next alignment inspection on the Reel.
